# **REFURBISHMENT OF LARGE DIAMETER PRE-STRESSED CONCRETE PIPELINES: B7 PIPELINE, A CASE IN POINT**

**Khathutshelo Godfrey Maumela Pr. Cert. Eng.; Kirk Canary; Nozibele Masondo (Ms)**

KG Maumela Pr. Cert. Eng., Executive Manager Bulk Water Distribution, Rand Water.  
N Masondo, Project Manager Rand Water  
K Canary, Project Manager Rand Water

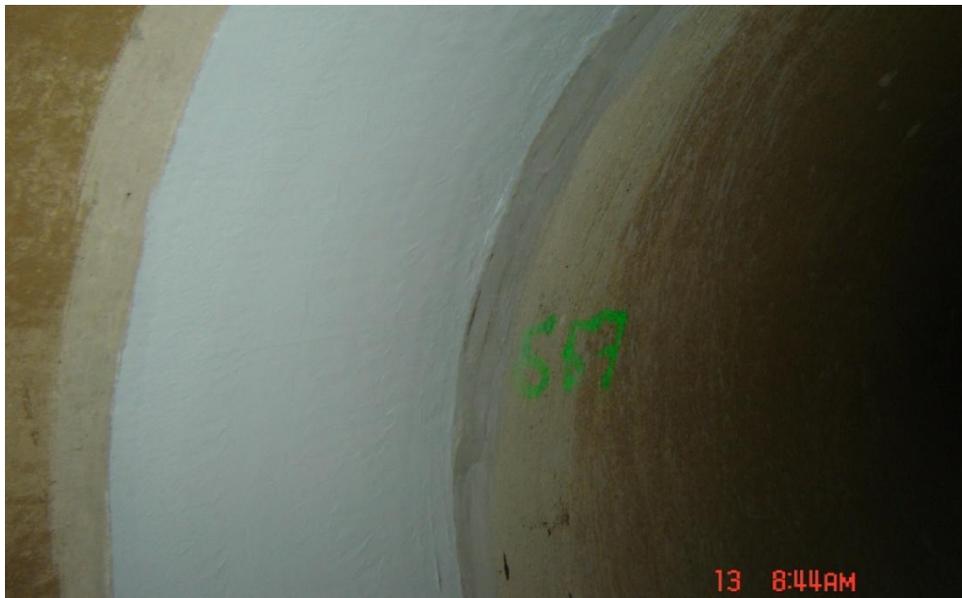
All quality control procedures are documented and reported. Figure 4 below shows the completed carbon fibre repair in the pipe.

*Figure 4: Carbon Fibre Repair*

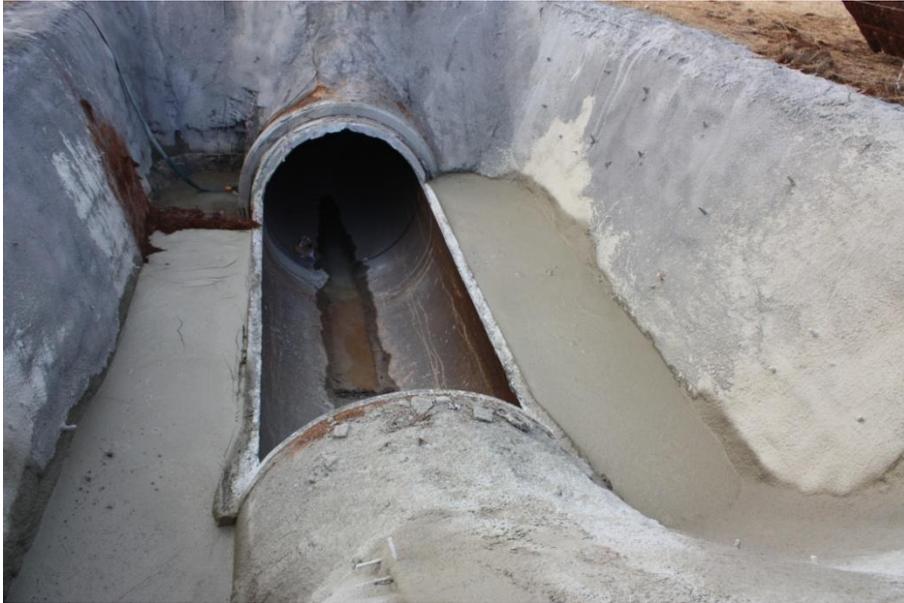
The plan is to cut into the existing concrete pipe to create a launch pit through which the steel pipe sections will be inserted into the host pipe.(See Figure 5).

*Figure 5: A typical Launch pit*

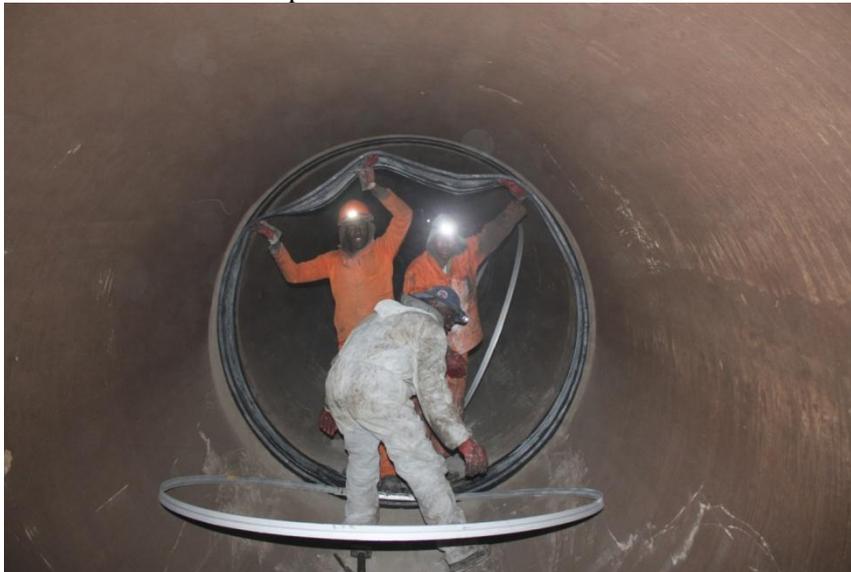
*Figure 6: Installation of EPDM Rubber seal*

- Wire brush joint area to remove loose surface.
- Apply an epoxy coating which is approved for the potable water industry (See figure 6)
- Install rubber seal with two stainless steel rings
- Jack to designed pressure – weld stainless steel straps into position
- Passivate welds to prevent oxidation.

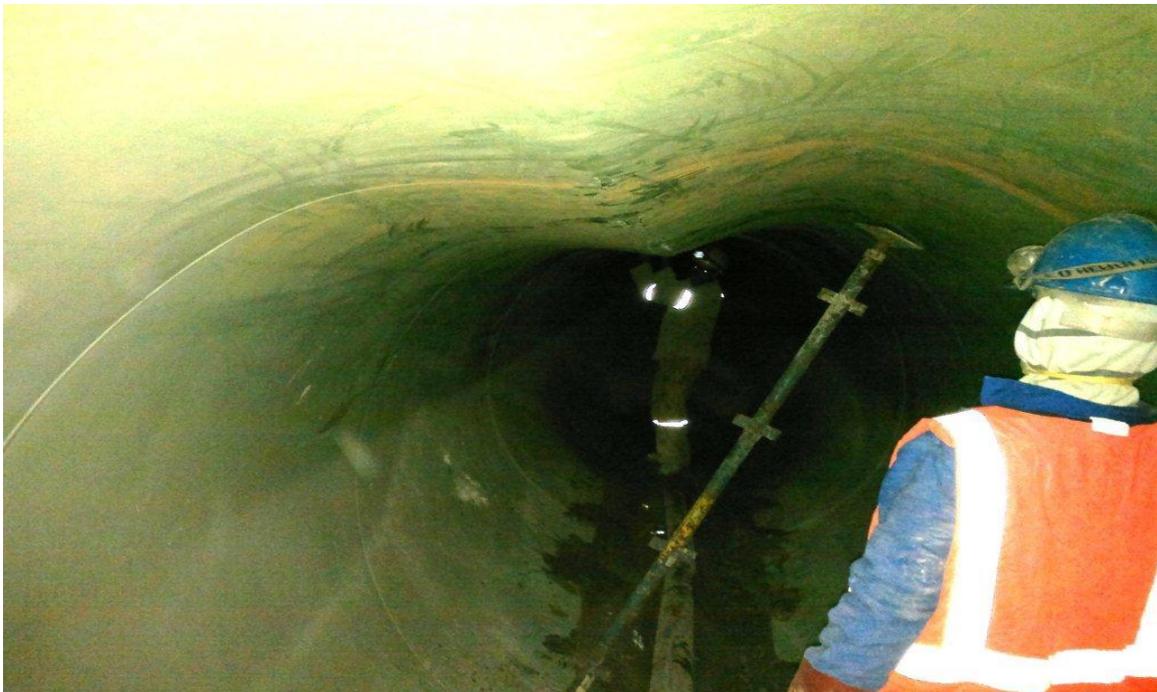
When pumping the grout, the pipes were not adequately propped, and the mix was pumped at a higher pressure, in an effort to fill the annulus. This resulted in buckling of sections of the steel pipe as can be seen in figure 7 below.

*Figure 7: Buckling of slip-lined pipe*

Buckling of the pipeline. Grouting of the pipes also commenced at a late stage of the construction period. The activity was delayed by two months due to the delay of acquiring welders. At that point an average of 94m<sup>3</sup> of grouting was required to be pumped in order to reach the target hand over date of the 28 July.

These sections were repaired by:

- Cutting out and removal of the buckled pipes
- chipping out the grout
- new sections of steel pipes were then launched to replace the damaged pipes

- adequate propping was employed

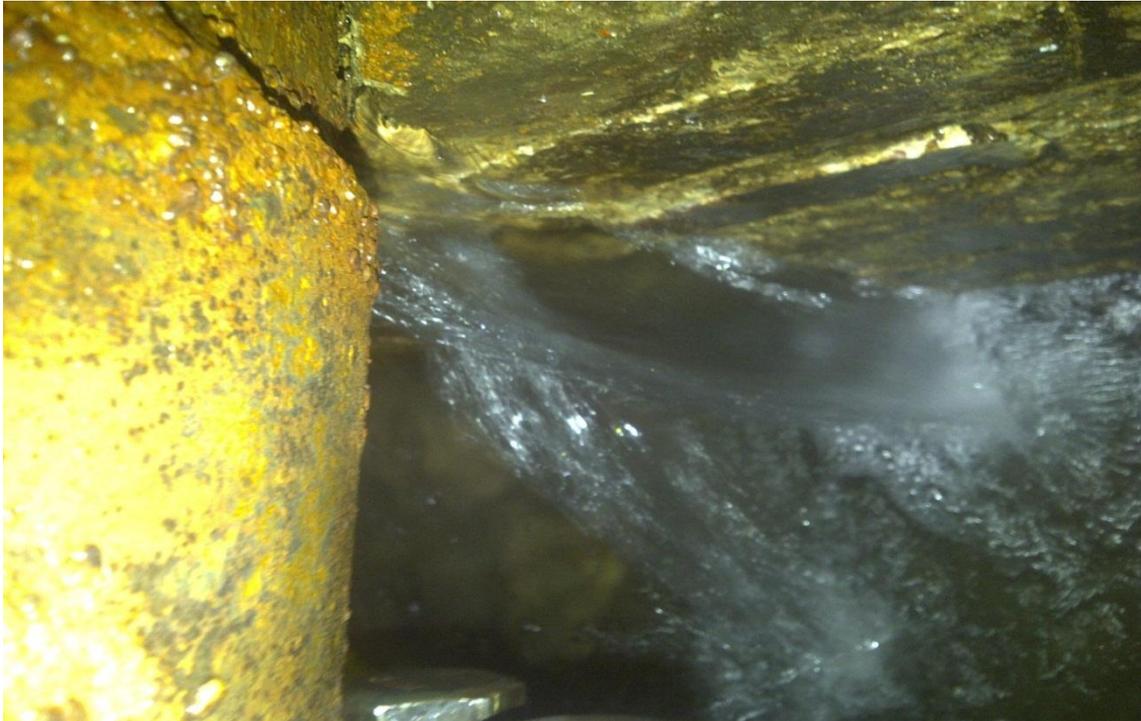
The pipeline was charged with water on 10 August 2012, two weeks behind schedule. During the pipe charging process, leaks were detected at three different positions along the pipeline, i.e. Leaking area at Pit no. 1F, Pit 2 and leaking scour valve as shown in figure 8 below.

*Figure 8: Leaking Scour Valve*

The scour valve leak was believed to have been because of the stolen adapter flanges which then created the leak problem.

The pipeline had to be drained so as to allow repairs to be conducted on the leaking areas. The welds were dye panned and showed no anomalies, and mass concrete was placed around leaking joints. New adapter flanges were also installed. The work was successful, but upon commissioning of the pipeline leaks resurfaced.

The results from the leak detection and CCTV survey showed no anomalies. The pipeline was then left in operation. Further assessments and repairs will be conducted when the next shutdown is offered during off peak season. The contractor was requested to do some external repairs on the three leaking areas. The leaks have since subsided.
