The Waterval Waste Disposal Facility: A Construction Supervision Case Study

G.A. Dode. Golder Associates Africa (Pty) Ltd, Pretoria, South Africa. gdode@golder.co.za
P.A. Legg. Peter Legg Consulting, South Africa. peterlegg@telkomsa.net

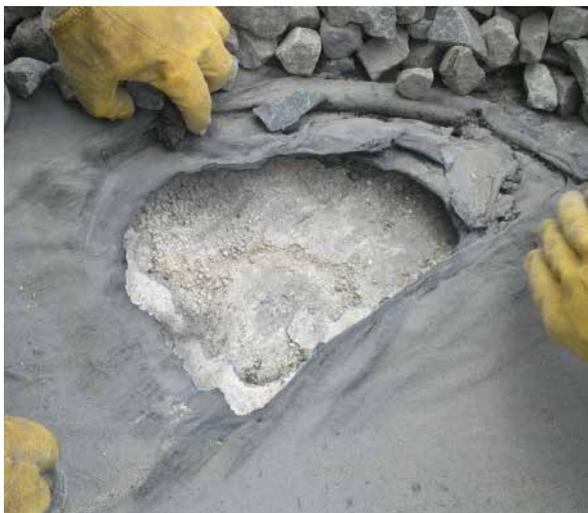
Whilst efforts are made to avoid damage to the installed materials, including GCL, HDPE or geotextile, this can be difficult to avoid completely. In the case of the Waterval project, the most common cause of damage to the geosynthetics was due to plant being driven directly over the material. Another common cause was the use of tools such as spades to remove sand or stone from the liner surface.

Figure 8. Liner damage by a tipper truck

Both Figures 8 and 9 are examples of damage to the liner system due to plant driving directly over it. In the case of Figure 8, a tipper truck delivering stone for the drainage layer on Cell 1 was not guided and reversed too far onto the Cell. In getting out again, the truck's tyres created a hole through all three geosynthetic layers (GCL, HDPE and geotextile). Figure 9 shows the case of damage caused by a skid steer which drove up a lined embankment before any protective layers had been applied.

All of the above cases were inspected by the Engineer and repaired by the Contractors without significant delays or additional costs. Larger holes in the GCL and HDPE are patched with additional material. Small holes in the GCL may be closed by using a bentonite paste while small holes in the HDPE are simply extrusion welded. In the case of the geotextile damage and insufficient overlap, the surrounding stone was removed and additional geotextile was placed on top of the affected area.

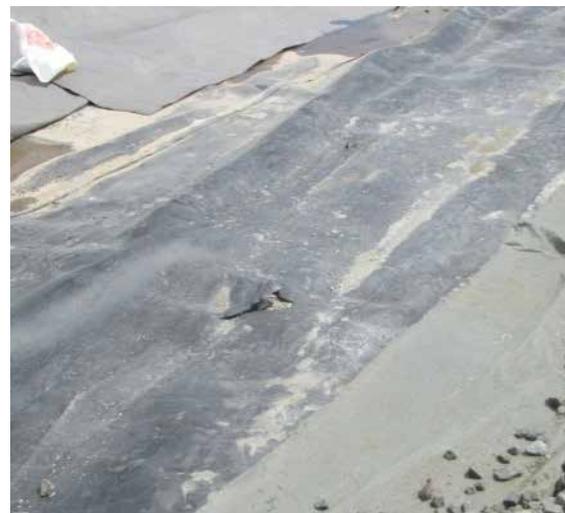
Figure 9. Liner damage by a skid steer

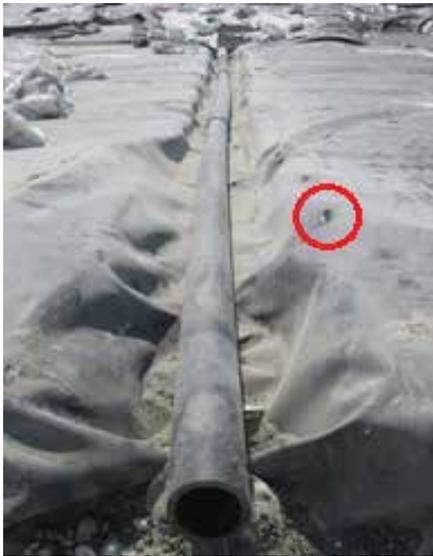
Figure 10. Liner damage from tools

Figure 10 provides an example of damage to HDPE on the Leachate Pond where spades were used to remove stone which was erroneously placed. Figure 11 shows damage to the geotextile on Cell 1 after being driven over by plant. Also evident from this photo is the fact that the geotextile overlap was insufficient and has thus separated after movement on the surface, allowing stone to come into direct contact with the HDPE.

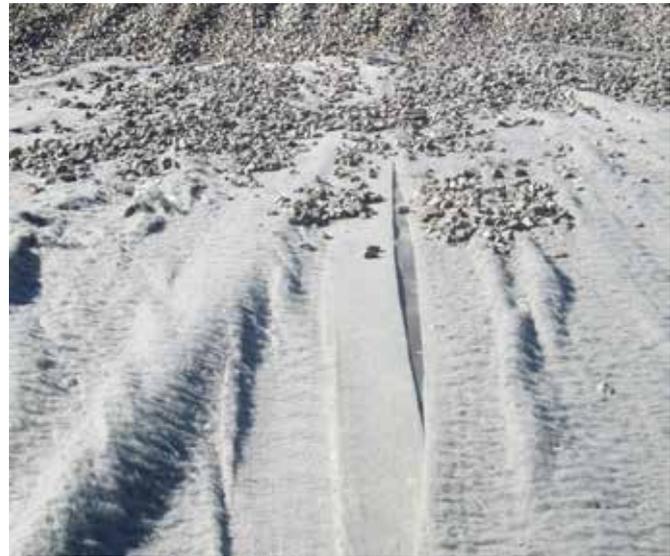
Figure 11. Geotextile damage

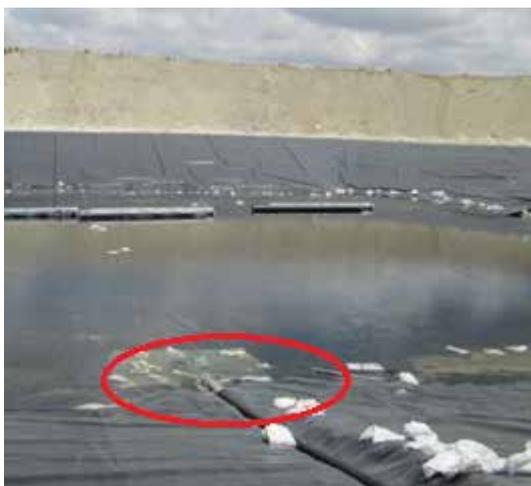
After the installation of the first liner layer (bottom) in the Contaminated Stormwater Pond, some significant rainfall events were experienced at the site. Due to the fact that the anchor trenches were still open (as two more liner layers were yet to be installed), stormwater which filled the trenches was able to pass under the liner in the Pond. This caused damage to the subgrade surface underneath the already installed liner, causing an uneven surface in certain areas (Figure 12). Further to this, the installed liner 'floated' in some areas due to the water under the HDPE (Figure 13). Upon further inspection it was also observed that the anchor length of the HDPE was not sufficient in isolated areas, which may have contributed to this event.

Figure 12. Surface damage under liner

In order to fix the damage caused, the water was first pumped out of the Pond before the HDPE could be cut open in the affected areas. The surface in these areas was repaired and recompact before being closed again.

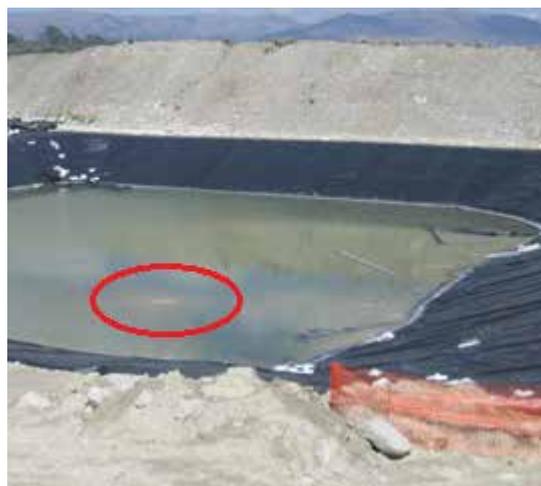
Figure 13. Floating liner

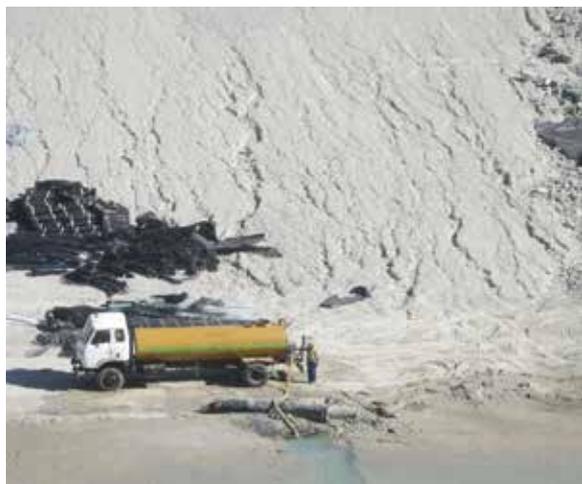
Due to a work stoppage over a period of approximately 3 months, the prepared subgrade surface in Cell 2 and the Rubble Disposal Cell was left exposed. Significant rainfall was experienced during this stoppage which caused significant erosion of the subgrade surface.

Figure 14. Rubble Disposal Cell surface damage

The subgrade surface was repaired by placing fine material on the damaged areas. The surface was then prepared by grading and compacting these areas as required.

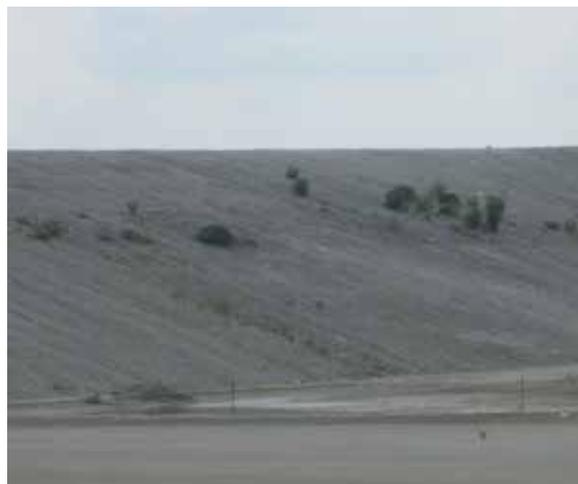
Figure 15. Surface damage on Cell 2

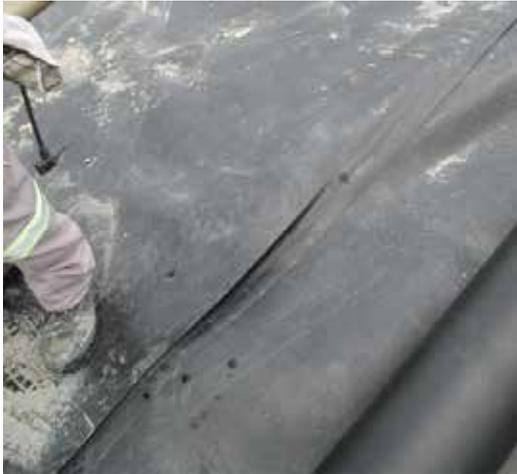
Wind can cause significant damage to liners during installation. The Waterval WDF experienced strong winds on several occasions during construction. In general, geosynthetic installation work is stopped when wind speeds are too high. In one case, a certain portion of installed HDPE on Cell 1 was not sufficiently secured over a weekend. High winds lifted a section of the liner and tore a portion of several metres next to a seam. The torn liner was repaired by patching it with additional HDPE and welding it closed again, before securing the liner with sand bags.

Figure 16. HDPE tear caused by strong winds

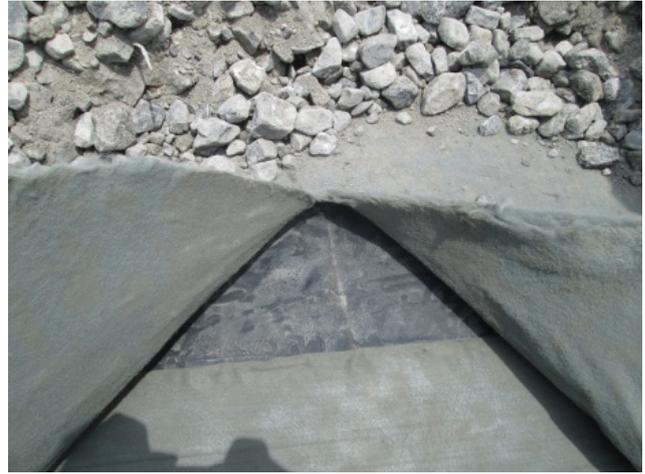
Figure 17. Inspection for damage to HDPE under geotextile

In order to check that the geotextile was accomplishing its purpose of protecting the HDPE under the load of stone delivery trucks, an inspection was carried out. The entrance path where the stone drainage layer was at its thinnest and through which all trucks passed, i.e. the area exposed to the most significant wear, was used as the inspection location. An area of stone was cleared and the geotextile was cut open to inspect the HDPE for any damage. As seen in Figure 17, no damage was observed. The HDPE was smooth, without any indentations, indicating that the 1000 g/m² geotextile was performing well under the loads experienced.
