Thermally Fused PVC Pipe Helps Accelerate Adoption of Trenchless Pipe Installation Techniques in North America

Co-Authors: Andrew D Seidel, Robert Walker
Underground Solutions, Inc.

This paper discusses the fused PVC pipe technology that is enabling trenchless growth and highlights two cases studies where fused PVC was utilised; a 3 800 foot (1 140m) HDD bore with 24 inch (600mm) and 6 inch (150mm) pipe pulled in simultaneously under a live airport runway in Portland, Oregon and a water utility in Colorado that has installed over 150 000 feet (45 000m) of fused PVC via the pipe-bursting method.

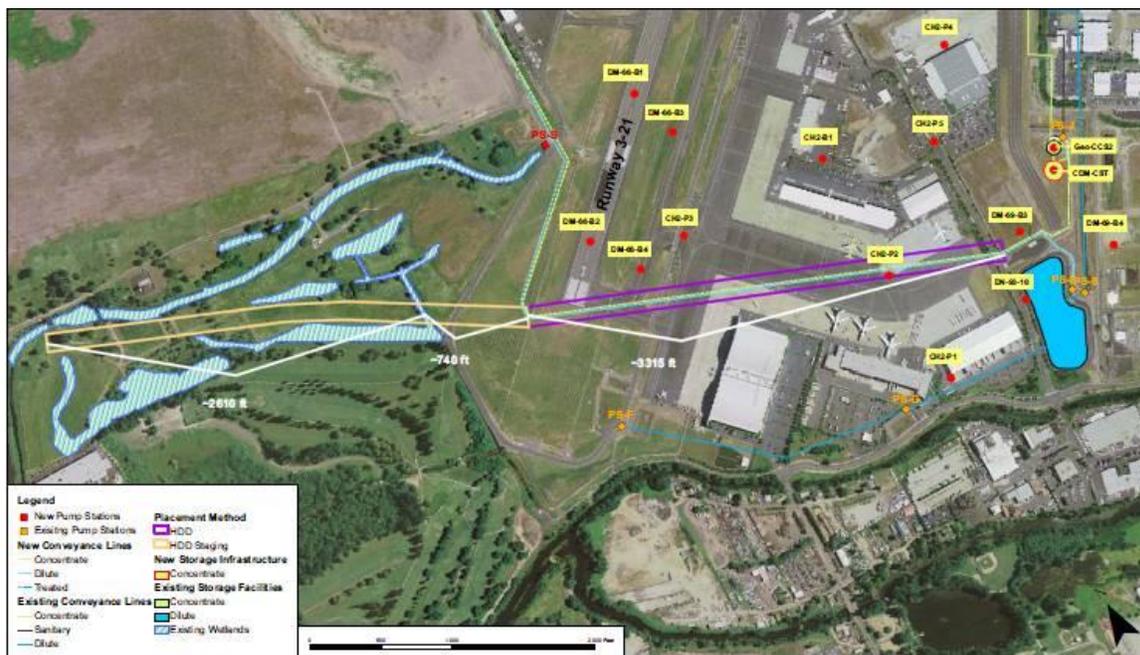
Figure 2: Proposed Boring Plan for the active airfield crossing (CDM, Geotechnical Data Report, June 2009).

After further and exhaustive review of potential options, evaluating potential risks and costs, HDD was advanced as the most cost efficient, viable option. Using historical geotechnical information (Figure 2) a proposed HDD boring plan was developed going under the cargo air operations and just south of the active runway (Figure 3). Due to the poor soils prevalent across the site, the proposed bore trajectory was taken to a depth of at least 75 feet (22.5m), where competent soils were expected. The Port was very wary of HDD installation methodology within the airfield, due to contractor miscalculations on a previous project that resulted in the emergence of a sinkhole adjacent to PDX’s south runway. To mitigate this potential risk, this crossing’s bore path alignment was carefully selected to provide numerous viable “work arounds” if there were a similar issue that occurred under the cargo area or the very southern end of the active runway.

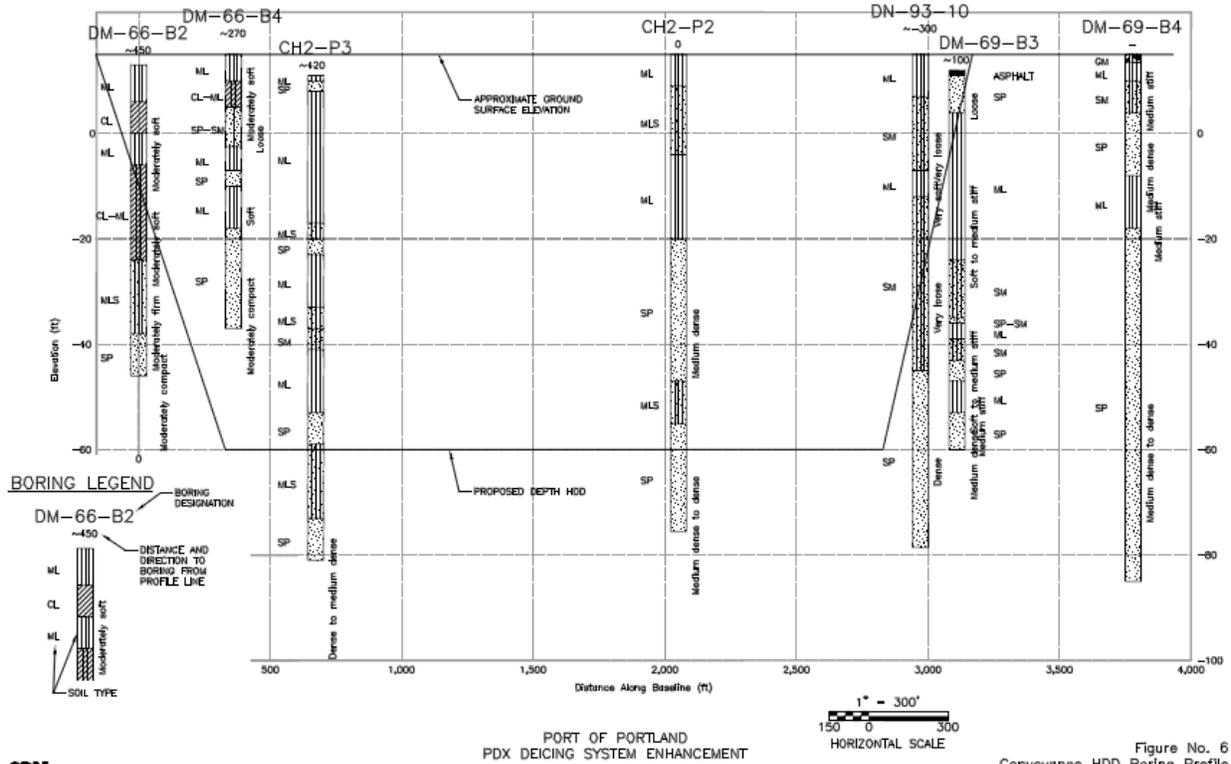
Figure 3: Results of the Boring Plan along the chosen HDD alignment (Geotechnical Data Report, June 2009)

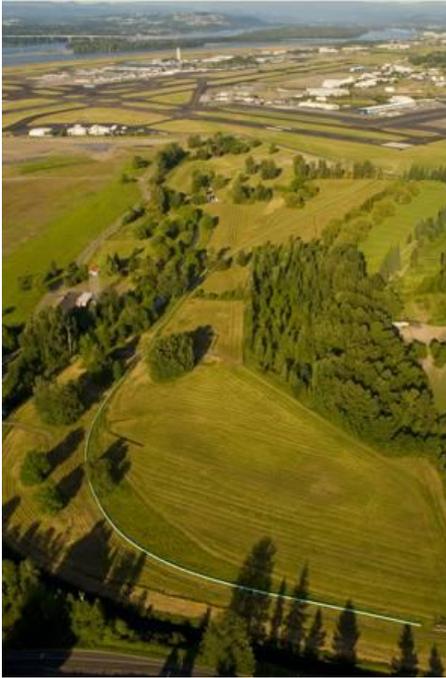
Figure 4: Lay-down area for the fused FPVCP sections

The required length of the bore, 3 800 LF (1 140m), was a significant length of pipe to fuse and stage – not only to string out in one length, but to make sure that it lined up with the crossing alignment. The fusion and lay-down area for the fused pipe (Figure 4) presented a major challenge because wetlands and environmentally sensitive areas that could not be disturbed existed in the work area that had to be used. JE Dunn, CDM, The Port of Portland, Kinnan, and UGSI ultimately identified an alternate alignment that did not disturb the wetlands, yet allowed for the full lengths for both 24” (600mm) and 6” (150mm) sections to be laid out.

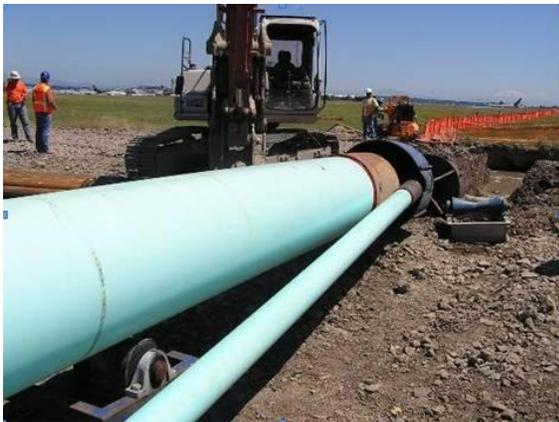
Figure 5: Start of Pull into the insertion pit

Kinnan custom-fabricated a manifold-style pullhead to separately link the 6 inch (150mm) and 24 inch (600mm) pipes and their individual pullheads simultaneously. Pullback commenced on July 27, 2010, with water ballast in the 24 inch (600mm) pipe to reduce frictional force in the bore. The pull was completed in 13 hours, exerting a maximum pull force of 117,000 pounds (520 kN). A successful pressure test was completed several weeks later.

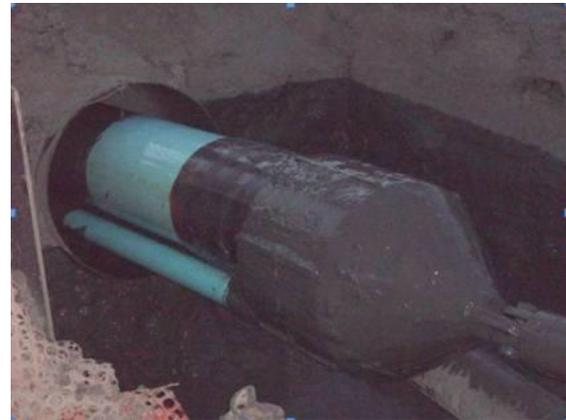
Figure 6: Pipe Bundle at Borehole Exit and Casing

The joint venture of Northwest Underwater Constructors (NUC) and Kinnan Engineering (Kinnan) was selected to perform the HDD for the airfield crossing. Underground Solutions, Inc. (UGSI) provided the FPVC pipe and fusion services for this crossing. During drilling, Kinnan encountered difficult and complicated drilling conditions. The same soils that precluded “jack and bore” methodology also had to be considered in the initial approach of the drill shot. Kinnan used a steel casing for the first ~120 feet (36m) of the installation to stabilise the bore.

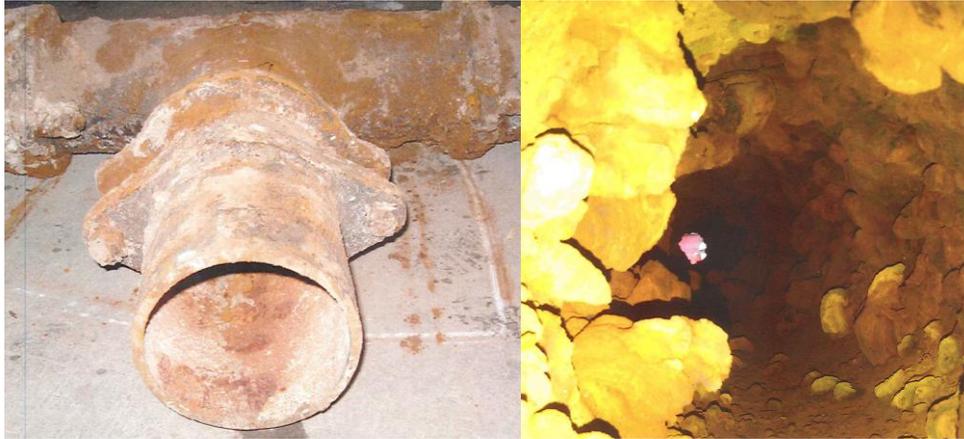
Figure 8: Typical water main in areas to be replaced, both outside and inside pipe showing tubercles.

Consolidated was facing the same aging infrastructure problem that many other utilities face, namely large sections of their system that needed to be replaced. These sections contained large amounts of undersized 4" (100mm) and 6" (150mm) cast iron pipe. The piping had served the system well over the years in these sections of the system, however due to large numbers of breaks, water quality issues and restricted flows in some areas due to tubercles and pipe size, it was becoming an ever-increasing concern.

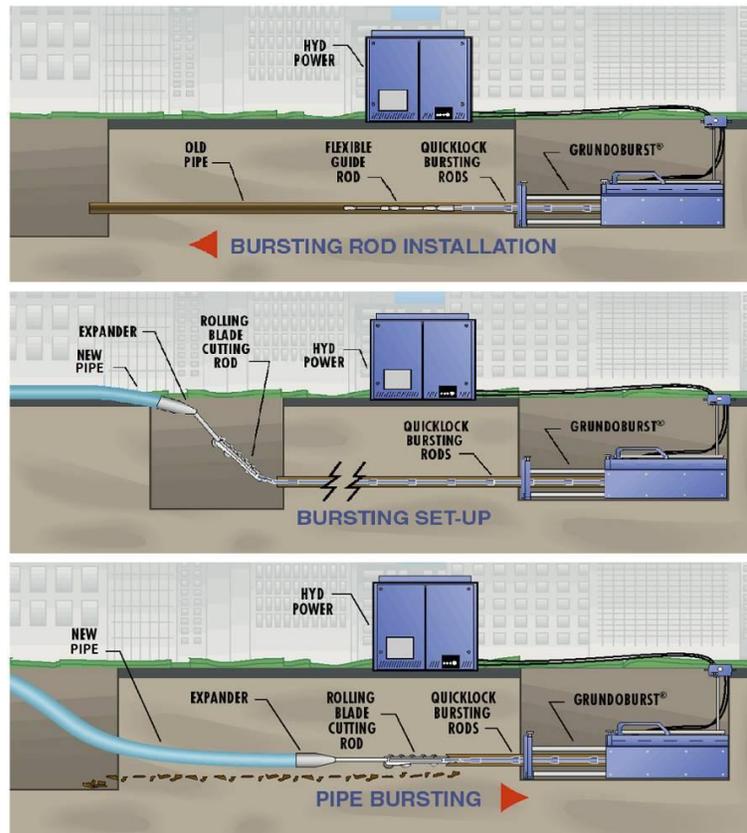
Figure 9: The static pipe bursting process illustrated.

Static pipe bursting has long been recognised as a viable form of pipe bursting and potable water pipe rehabilitation (U.S. Water Standards AWWA M28, 2001). Today, static pipe bursting has come to the forefront of trenchless methods in North America. During the static bursting process specially designed bladed rollers are pulled through an existing line by a hydraulically powered bursting unit. As the bladed rollers are pulled through, they split the host pipe. An expander attached to the rollers forces the fragmented pipe into the surrounding soil while simultaneously pulling in the new pipe (see Figure 13).

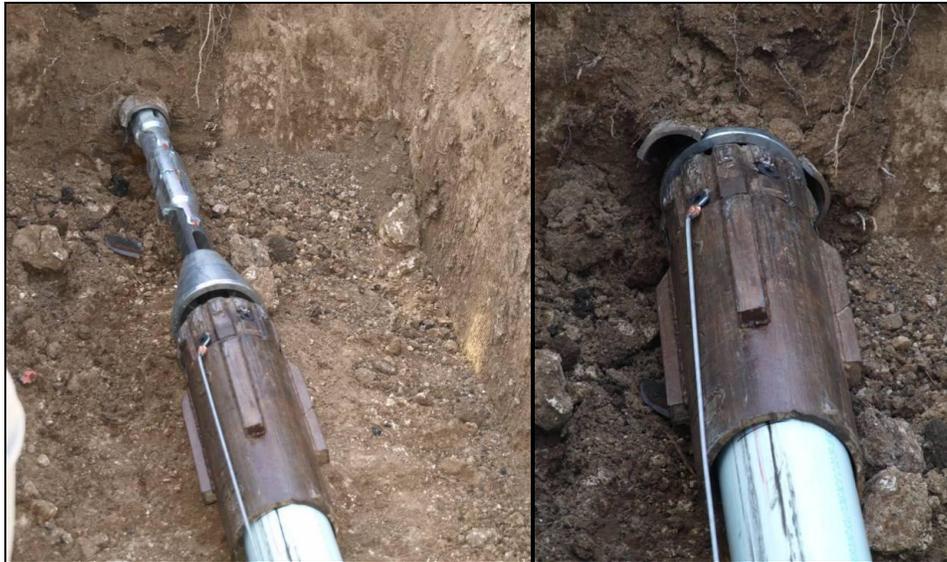
Figure 10: Pipe bursting a 4 inch (100mm) cast iron water main and upsizing to 6 inch (150mm) FPVCP.

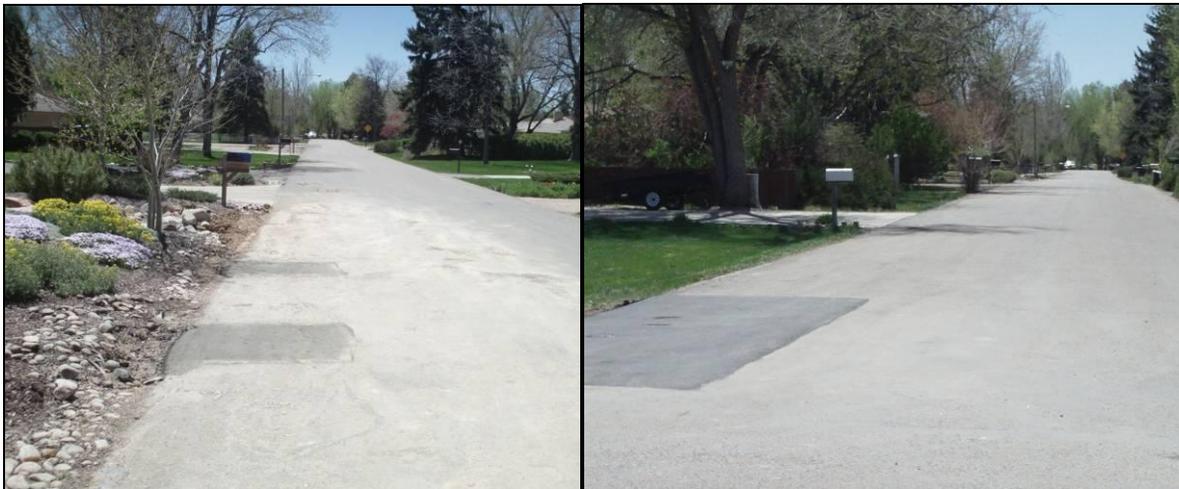
Figure 11: Final restoration in areas of pipe bursting. Asphalt patches shown in relation to rest of street.
