# **AN INNOVATIVE APPROACH FOR THE OPERATION AND MAINTENANCE OF ZEERUST WASTEWATER TREATMENT WORKS**

**By Casper Coetzer and Hendrik Honey**

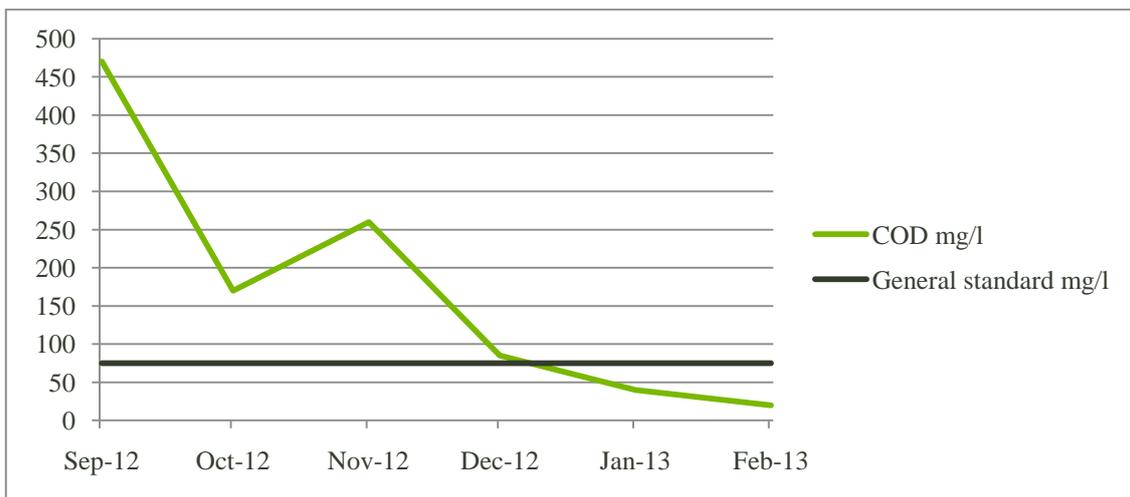
Figure 1: Effluent COD values

Results of the most important effluent parameters are indicated in Figures 1 to 5 below. These graphs clearly show the steady improvement in effluent quality, up to the point where all parameters complied with the required standards when the works was handed back to the NMMDM in March 2013.

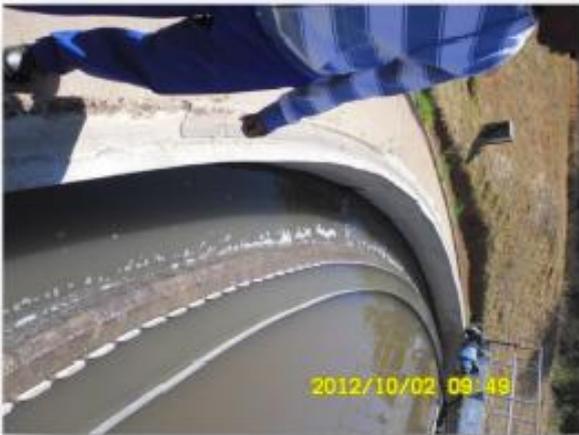
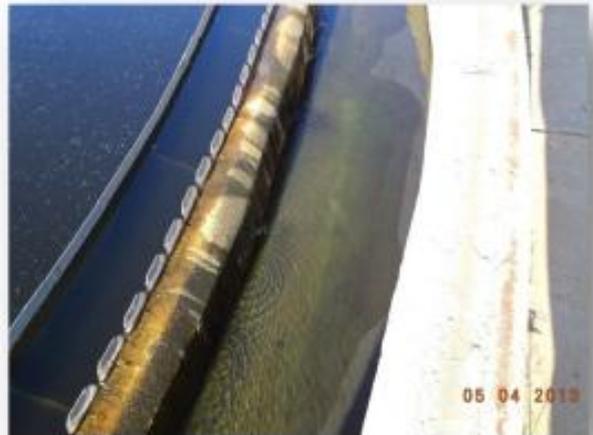
Photos 1 to 4 show the visual improvement in effluent quality before and after the refurbishment and O&M periods.

Photos 1 and 2: Visual improvement in the effluent quality between October 2012 and April 2013 at the overflow of the secondary settling tanks

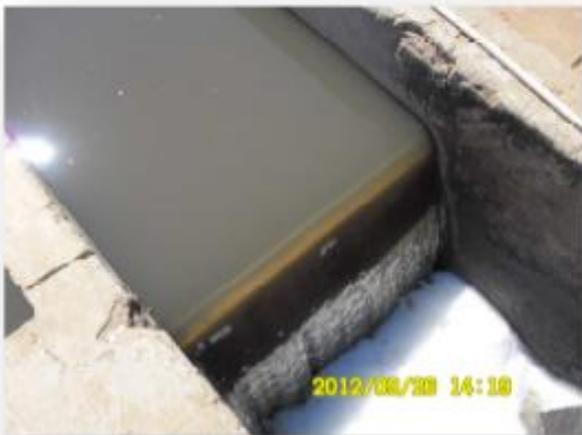
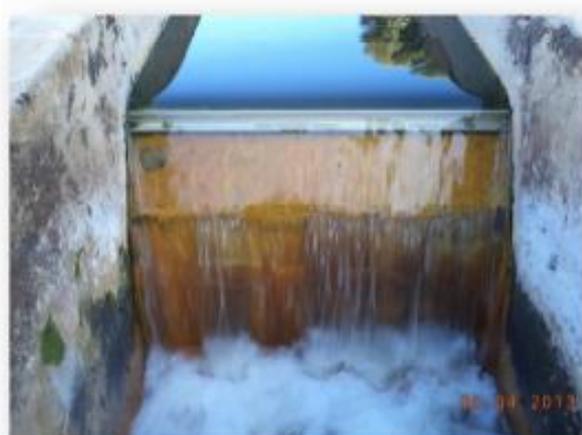
Photos 3 and 4: Visual improvement in the effluent quality between October 2012 and April 2013 at the overflow of the chlorine contact tank
